CWA COMPLIANCE EVALUATION INSPECTION REPORT
U.S. ENVIRONMENTAL PROTECTION AGENCY, REGION 5

Compliance Evaluation Inspection

Skyline Blue Acres

April 20, 2017

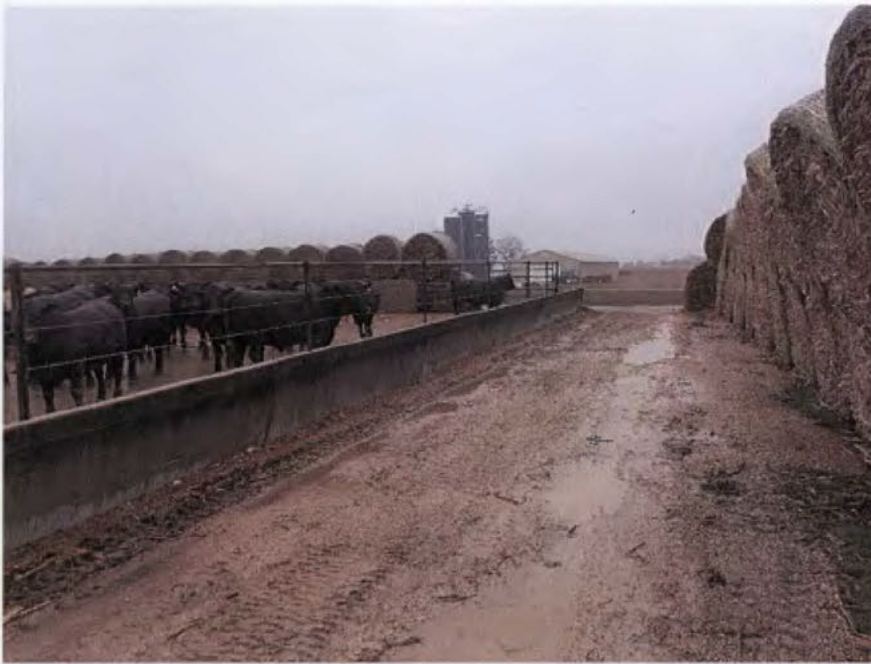
38: P4200038

EPA noted a small amount of feed on the outside of the ground outside the feed troughs and many round bales of hay were stored just to the north of and on the west side of the open lots. Blowoff of hay and process wastewater from any feed outside the feed troughs would flow to the west and to the crop field.

Description: A small amount of feed was on the ground outside the feed trough for the open lots. Round bales were located to the north of the open lots.

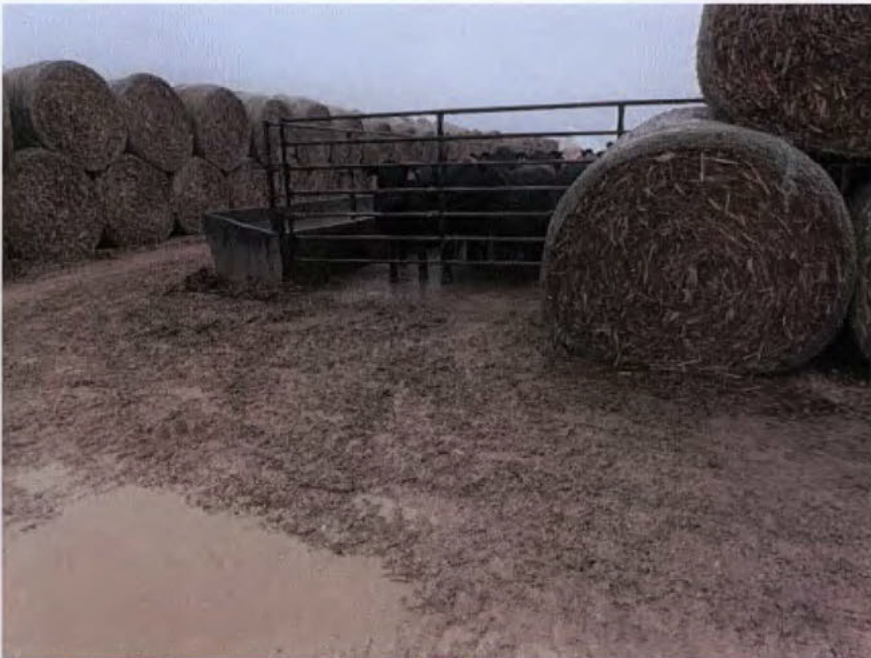
39: P4200039

Description: West side gate for the open lots. Manure and process wastewater from the open lots would flow to the east and toward the Manure Pond. There was a small rise in the ground outside the gate that prevented manure and process wastewater from flowing to the west.

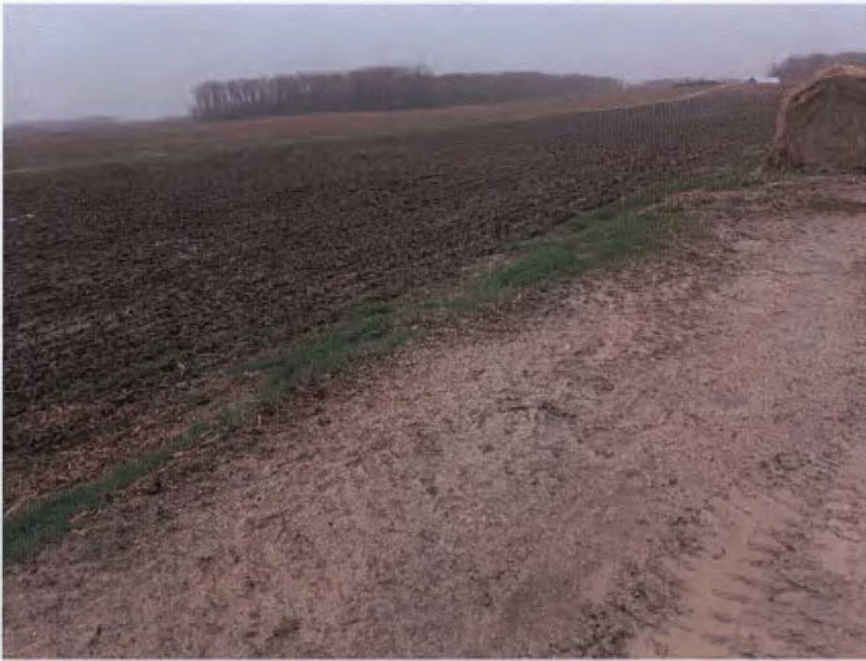
40: P4200040

Description: EPA did not observe any channeling or flow of manure or process wastewater from the open lots to the west and to the crop field.

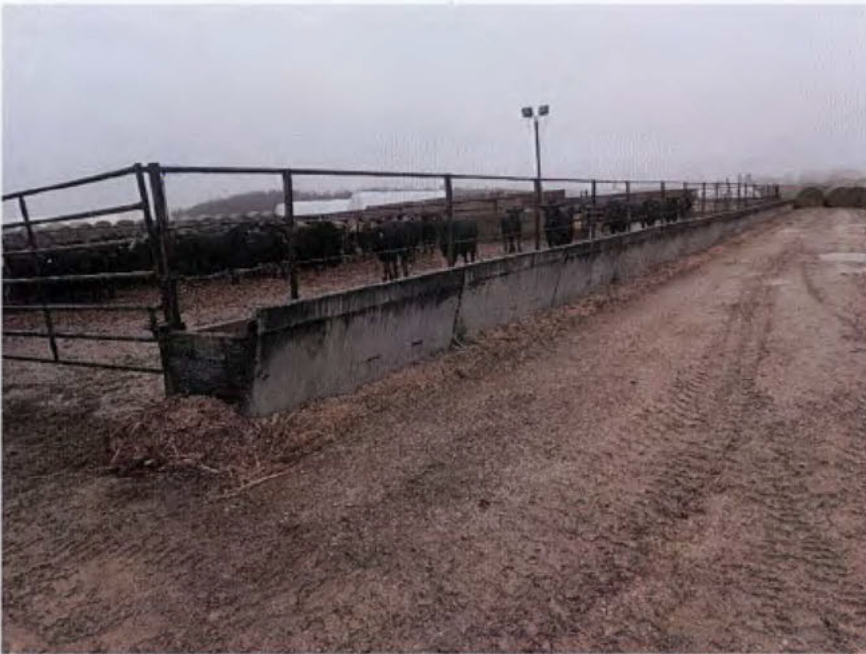
41: P4200041

Description: Small amount of feed on the ground outside the feed trough on the south side of the open lots.

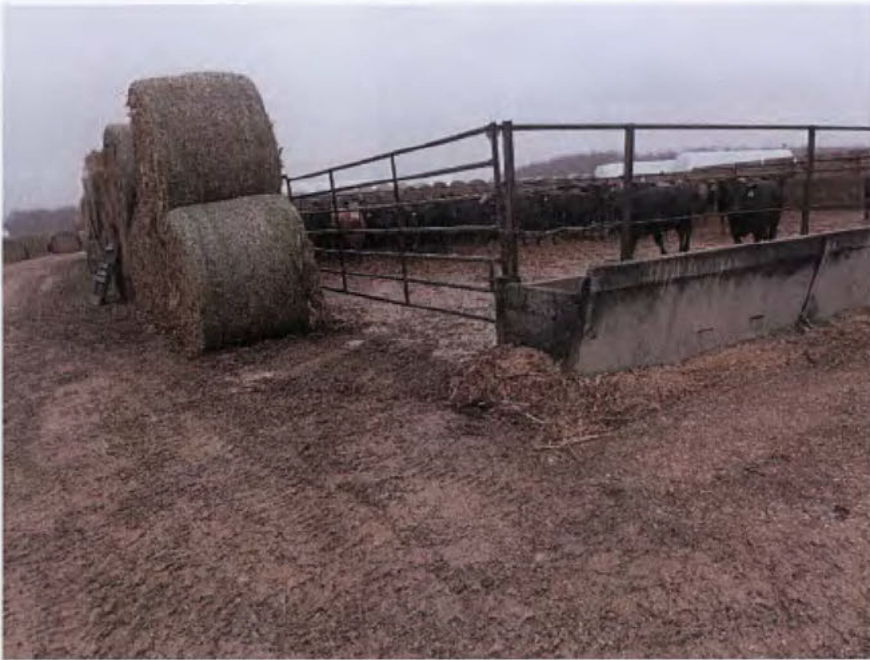
42: P4200042

Description: EPA did not observe any flow of manure or process wastewater leaving the open lots on the west side.

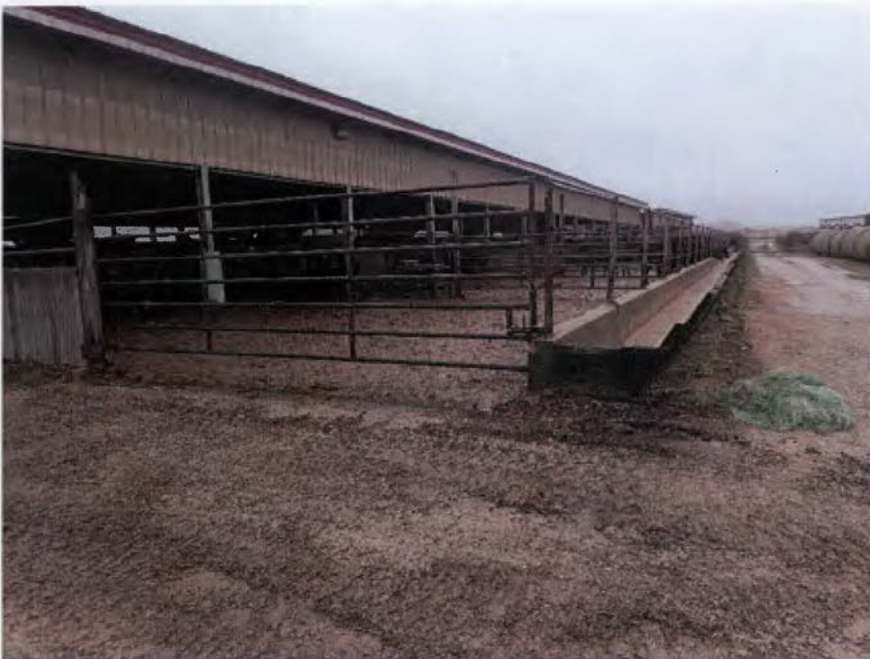
43: P4200043

Description: Feed trough for Barn #3. Note the concrete mountable curbing below the gate.

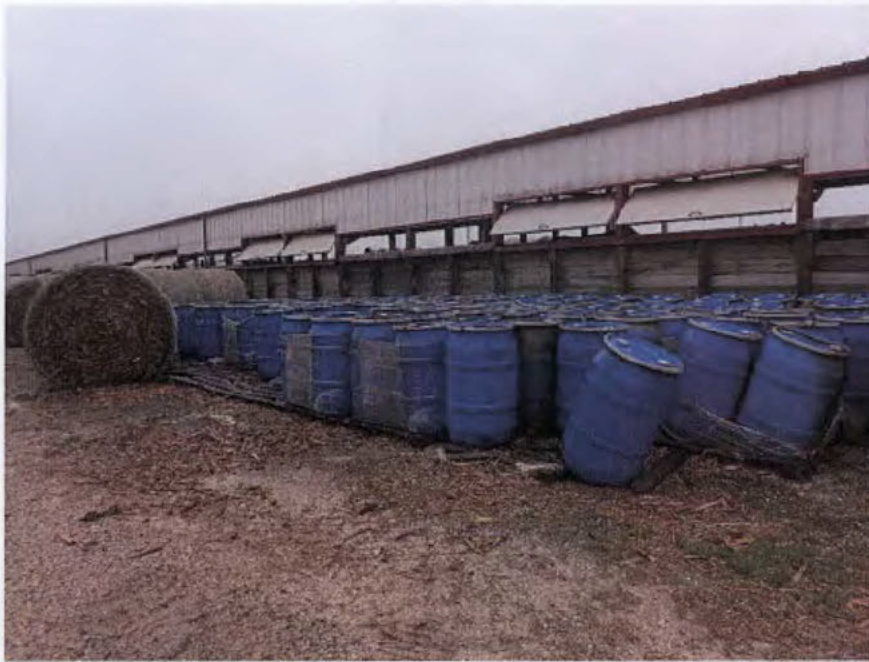
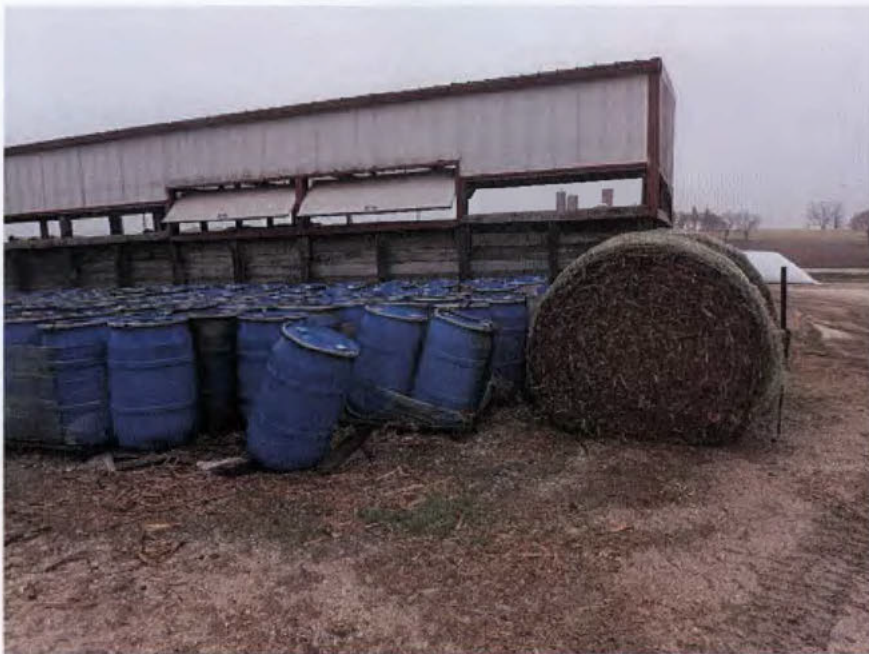
Description: Barrels contain Maltodextrin extract, a food additive.

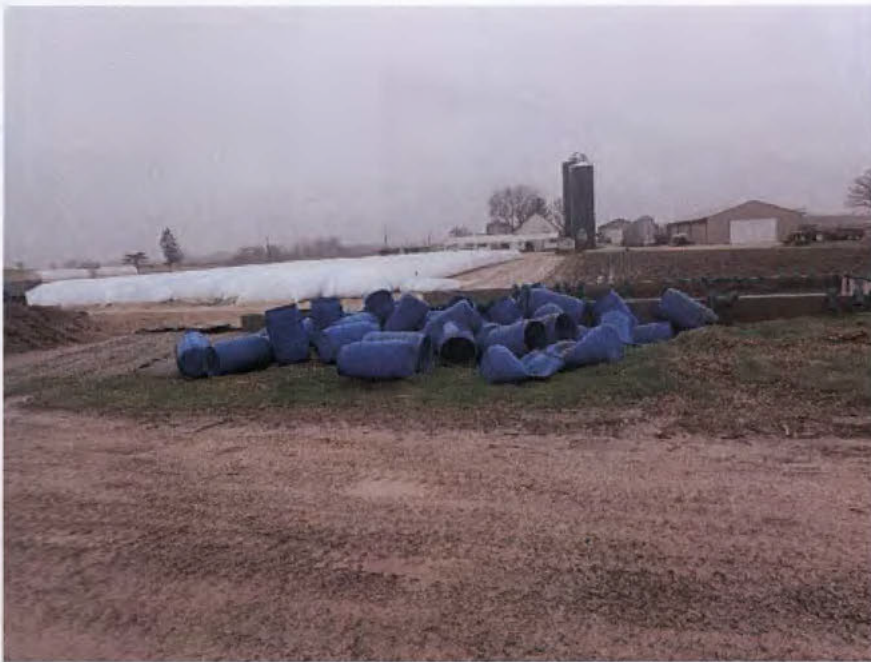
46: P4200046

Description: Empty barrels are piled for pickup for recycling.

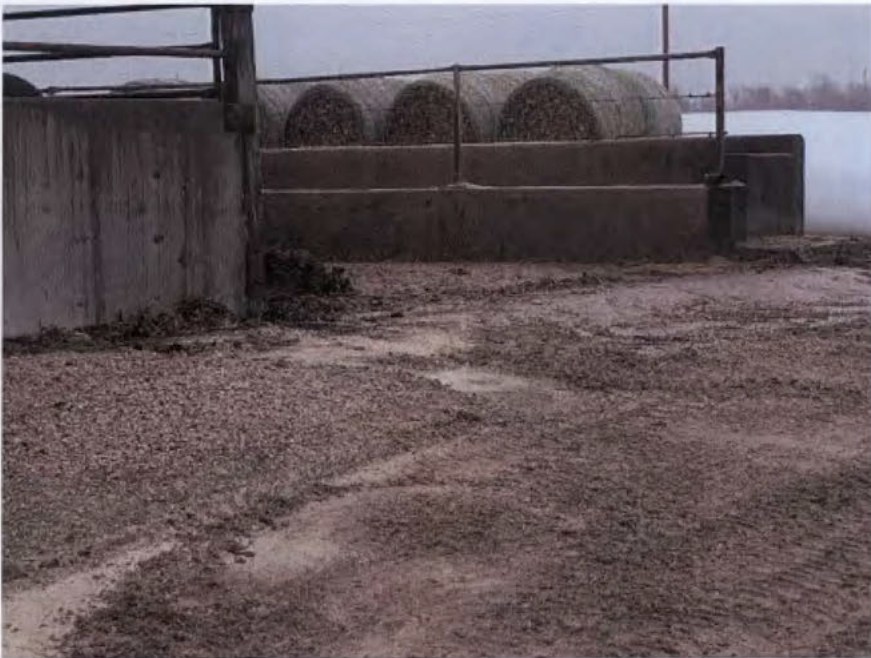
47: P4200047

Description: Mountable concrete curbing at opening to Barn #4.

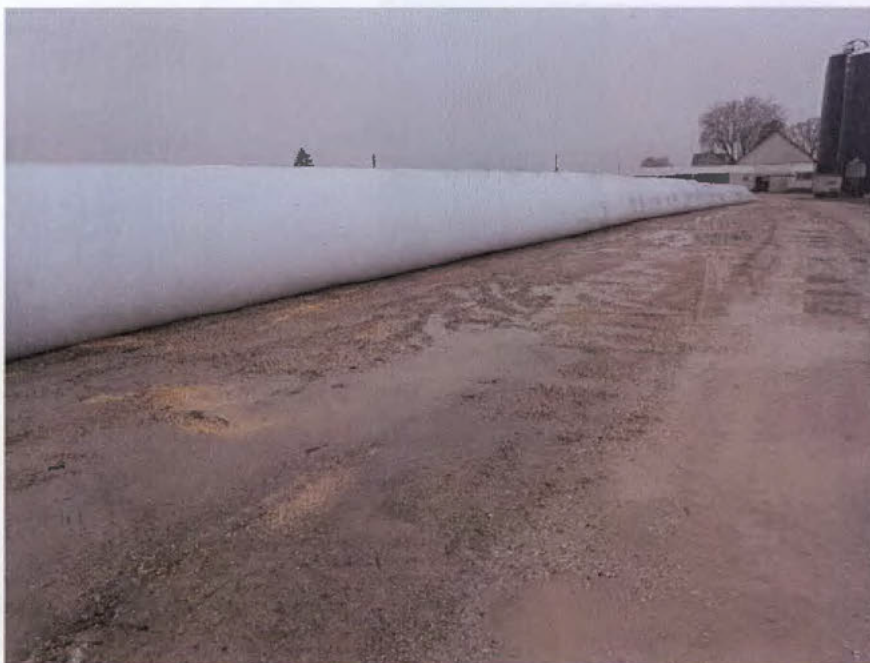
48: P4200048

EPA then walked west along the silage bag area and noted that the bag furthest to the north was almost completely emptied. A very small amount of feed was left on the ground near the opening of the bag, but EPA did not observe any additional spilled silage where the bag had

Description: An almost completely used bag of silage is just out of camera view at lower left. Photo shows the small amount of silage on the ground where silage bag was emptied.

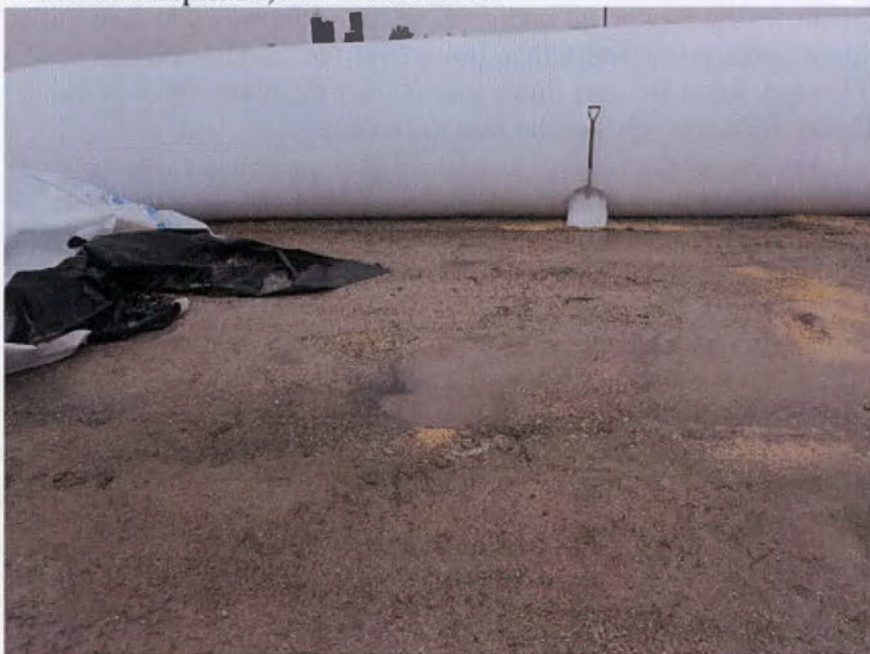
49: P4200049

Description: Facility owner states that they keep a shovel near the open end of any silage bag for immediate clean up any spilled feed.

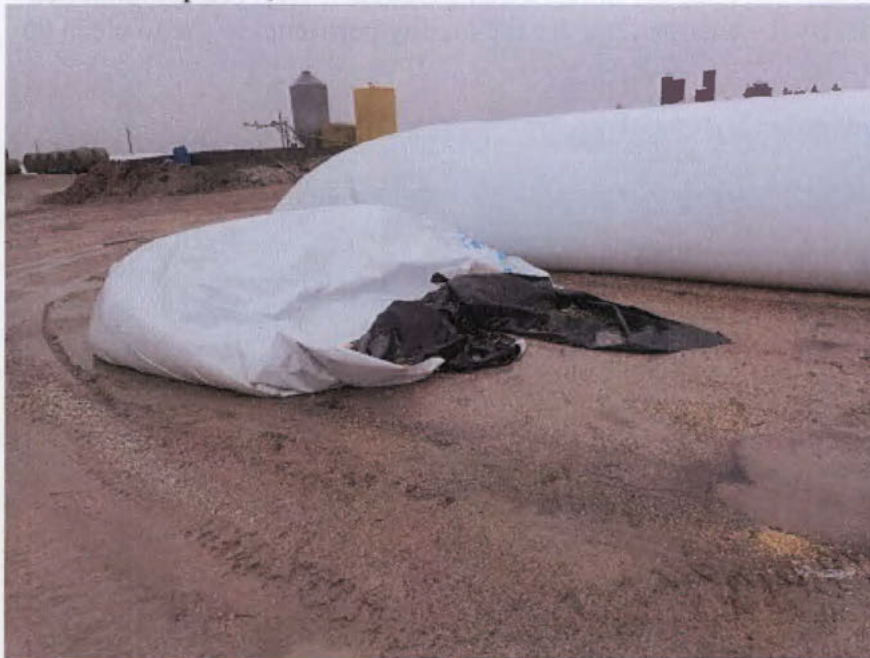
50: P4200050

Description: Silage bag is almost completely emptied. Facility owner stated that they leave enough plastic on the edge to keep the open end closed when not removing feed.

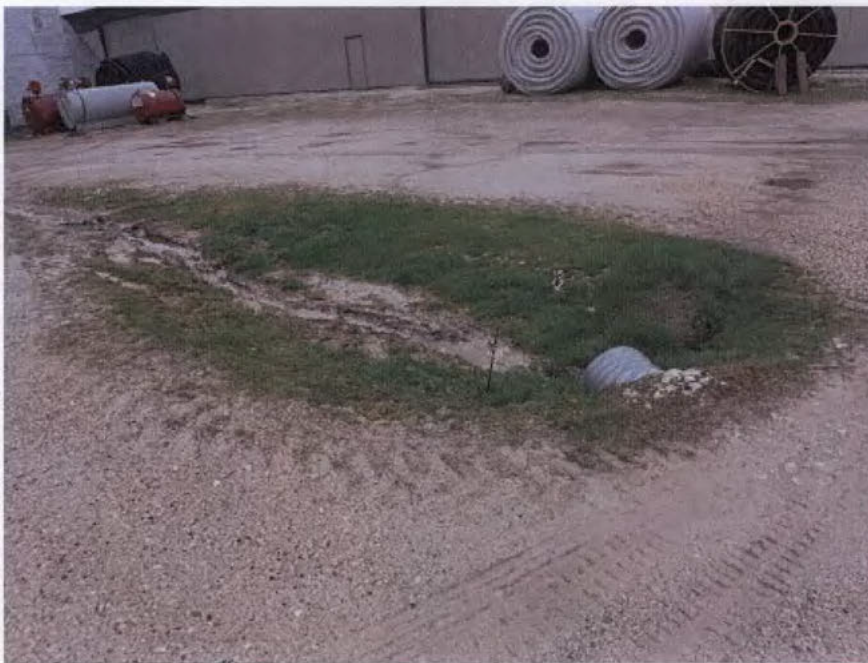
51: P4200051

Description: Inlet under facility driveway for intermittent unnamed tributary of Black Creek.
Flow of the stream is from the north.

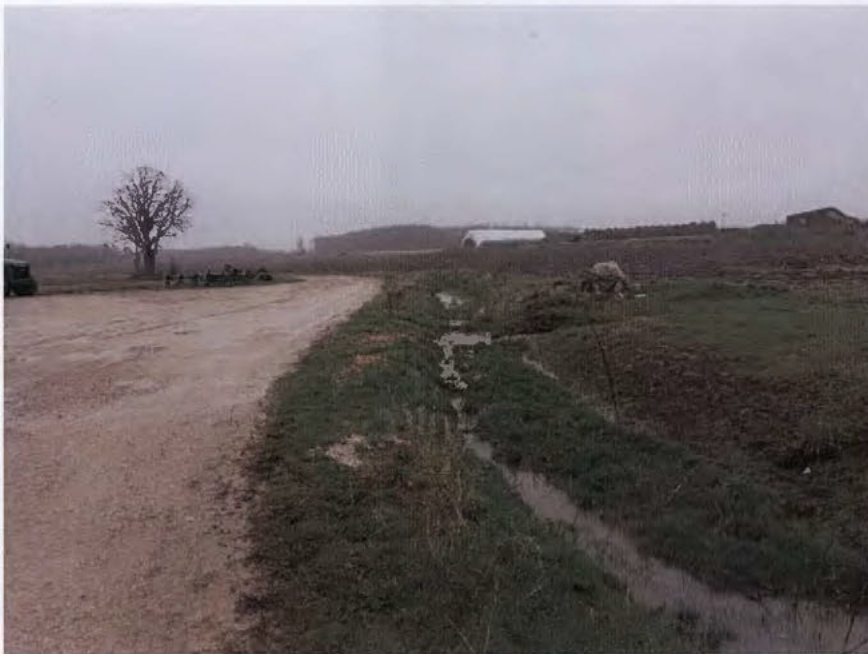
52: P4200052

Description: Looking upstream at the intermittent unnamed tributary of Black Creek which flows from north to south.

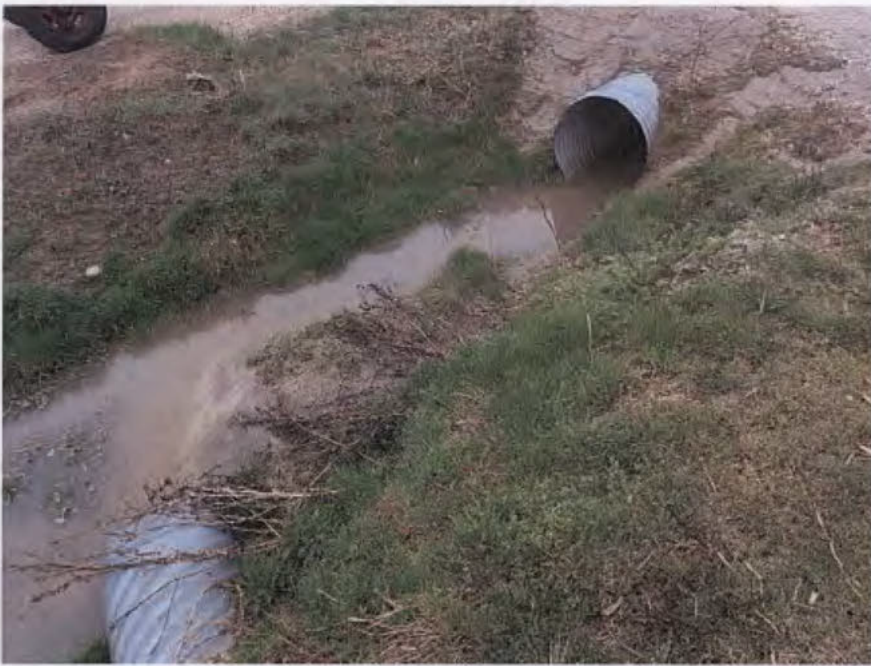
53: P4200053

Description: Outlet of culvert pipe for intermittent unnamed tributary of Black Creek under facility driveway and into another culvert which transports the flow to the south.

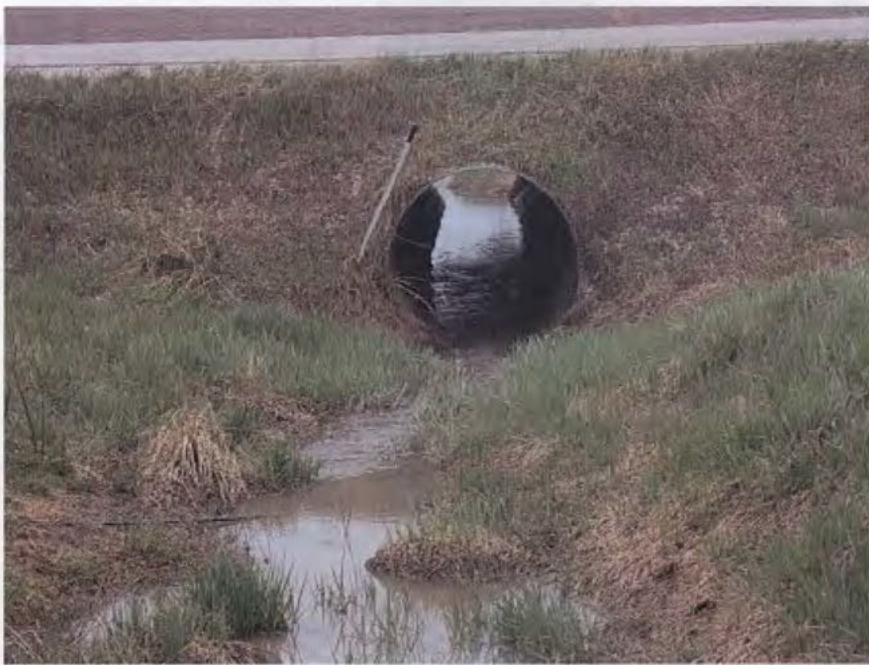
55: P4200055

Description: Culvert under County Road BB for intermittent unnamed stream of Black Creek.
